ENGINEERING REPAIR REPORT

SHIH WEI-CHIEH – “I AM VERY HAPPY I HOPE YOU ARE TOO”
HEADDRESS ARTEFACTS

PREPARED BY ALBERT ONG

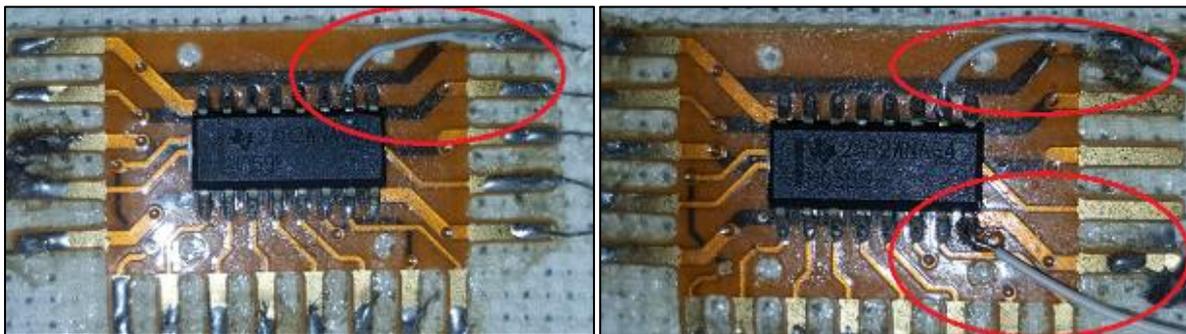
Upon visible inspection, we identified no visible damage to ICs (based on physical damage, burns or corrosion), and no cold solder joints were observed. However, jumper wires were observed (see Figure 2) to be soldered between components, film circuit boards and printed circuit boards, suggesting previous repairs/modifications were performed to address problems with electrical discontinuity (broken wires in the circuit) by acting as redundant/replacement connections.

Figure 2 – Two different shift Register ICs mounted on film circuit boards. Note jumper wires (white wires circled in red) not originally part of the existing film circuit boards are soldered.

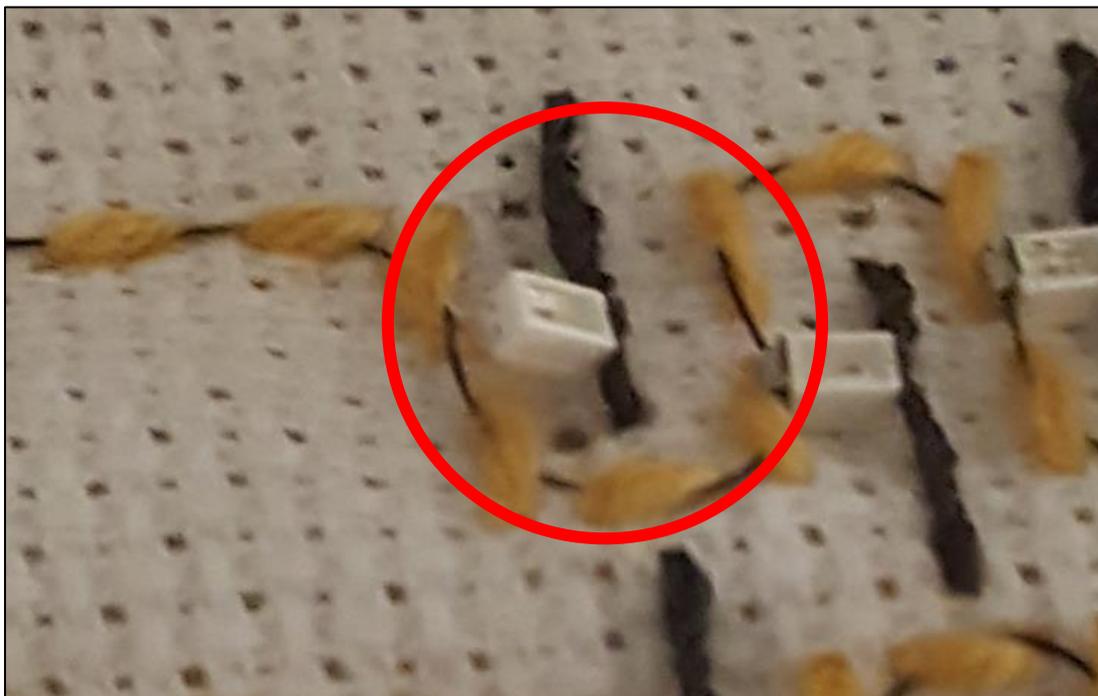
Further inspection of the LEDs uncovered a number of LEDs with damaged or missing legs (see Figure 3). The missing leg(s) render the LED non-functional and will require replacement of the LED.

Figure 3 - LED with damaged/missing clip leg requiring replacement (circled in red).

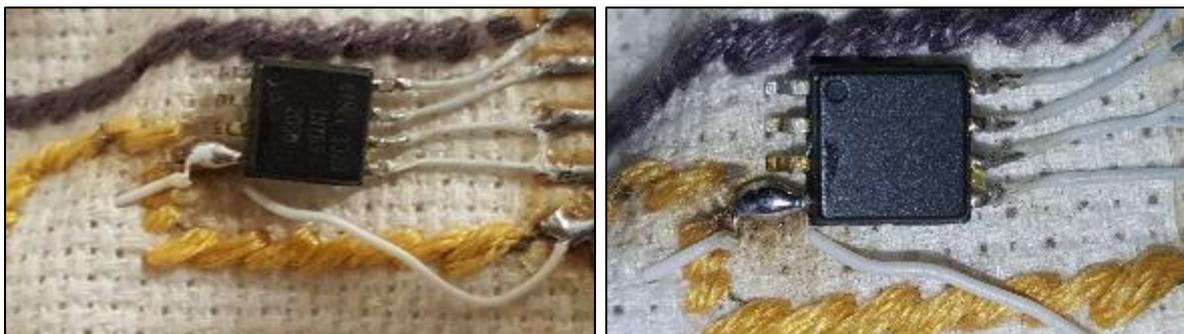
ATTiny85 microcontroller ICs were soldered to film circuit board pads with jumper wire extensions (see Figure 5) from the IC legs. However, the ATTiny85 ICs themselves were not adhered to the fabric in any way, posing a risk of damage from mechanical stresses/vibration. Further, because ATTiny85 microcontroller ICs were hand soldered to the jumper leads, the size of the solder joint is typically inconsistent, and large joints (see Figure 5 (right)) risks electrical shorting with adjacent legs.

Figure 5 - ATTiny85 microcontrollers connected to SN74HC595 film circuit board using jumper wires to extend legs (left). Large solder joint (right) risks an electrical short to adjacent leg (which should not be electrical connected).

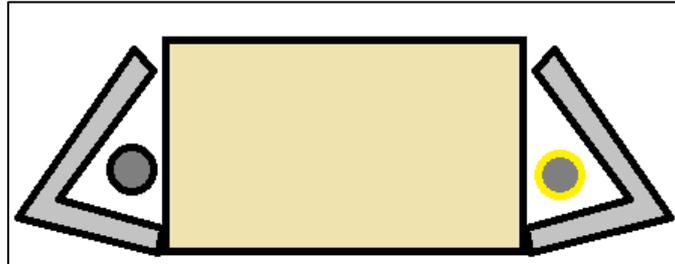
From observing with a magnifying glass, there was a clear gap between the LED wing legs/clips and the conductive wire. This is illustrated in Figure 9. This air gap demonstrates that the crimps do not bite down onto the thread, and thus cannot establish nor maintain electrical connection.

Figure 9 - Illustration of LED with wing legs/clips, and thread wires. Note that the crimps do not 'bite' onto the wire, and because of this, electrical connection is not maintained, resulting with non-illuminating LEDs

An alternate option was to crimp the legs together to maintain contact by squeezing the contacts into the LED. Doing this makes the LED contacts "bite" into the thread, and this ensures electrical connection with the black/yellow thread wires. However, due to the brittle nature of the LED wing crimps, a small number of these snapped off entirely, rendering these particular LEDs non-functional; these LEDs require replacement.

- Crimping LED contacts to ‘bite’ onto the thread wire – this mechanically ensures electrical connectivity, but there is a risk of snapping the LED contacts in the process,
- Applying solder, or some form of conductive adhesive, between LED contacts and thread wires – this fills any gaps, but risks affecting the appearance of the artefacts,
- Tying the thread wire around each LED contact tightly to ensure connection – given the large number of LEDs, this approach is laborious, and mechanical vibration or changes in the environment can cause the thread wire loops around the LED contacts to loosen over time.
- Selection of an alternative model of LED which accommodates for any of the above points.

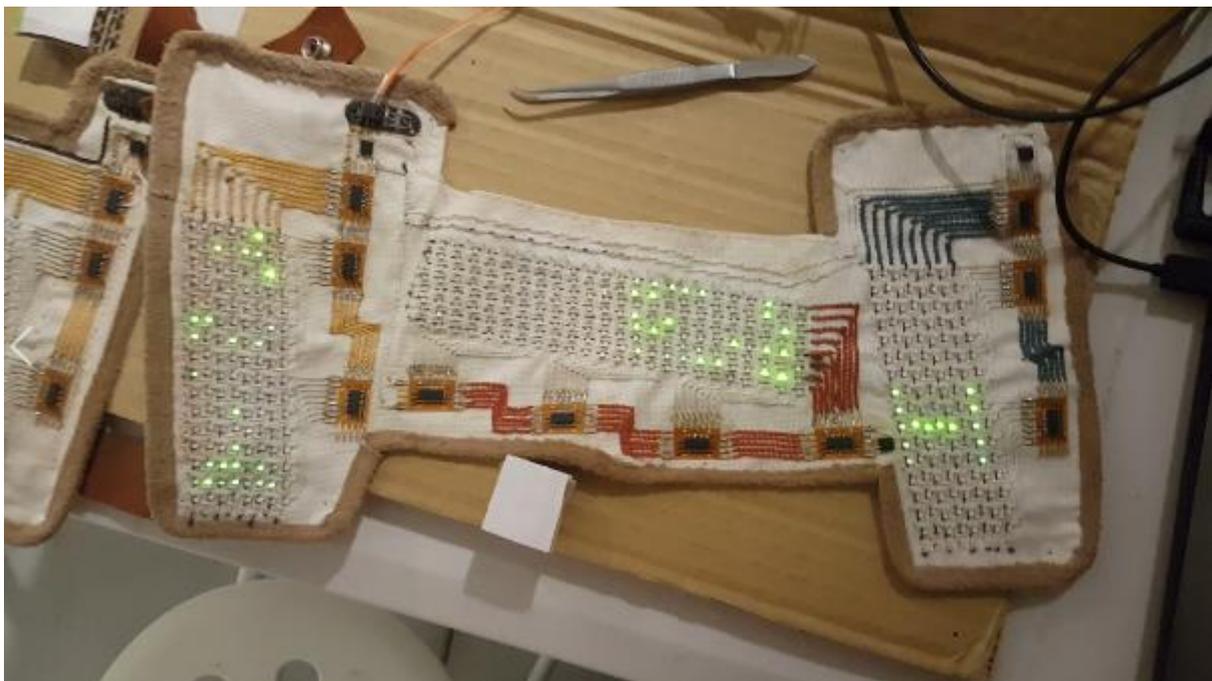
Figure 10 LED sections appeared after crimping the LED wings. This allows the LED to 'bite' onto the conductive thread wires, and establish electrical connection.

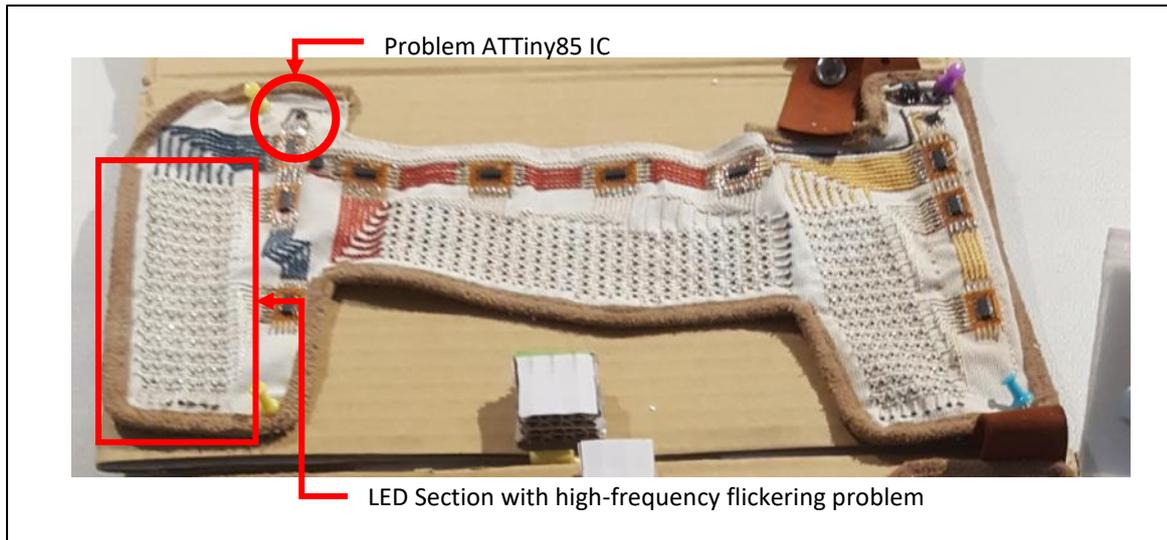
On one section of LEDs on one of the wings, the entire section was found to be continuously flickering at a high frequency (identified once LED wings were crimped and LED functionality was restored). We suspected that there was corruption in the ATTiny85 microcontroller, which controls this section of LEDs.

Figure 12 - LED Section with high-frequency flickering problem, suspected to be due to a corrupted/damaged ATTiny85 microcontroller

In order to restore scrolling text in the LED section highlighted in Section 4.4, the ATTiny85 microcontroller IC needs to be re-flashed, or replaced and re-flashed with source code.

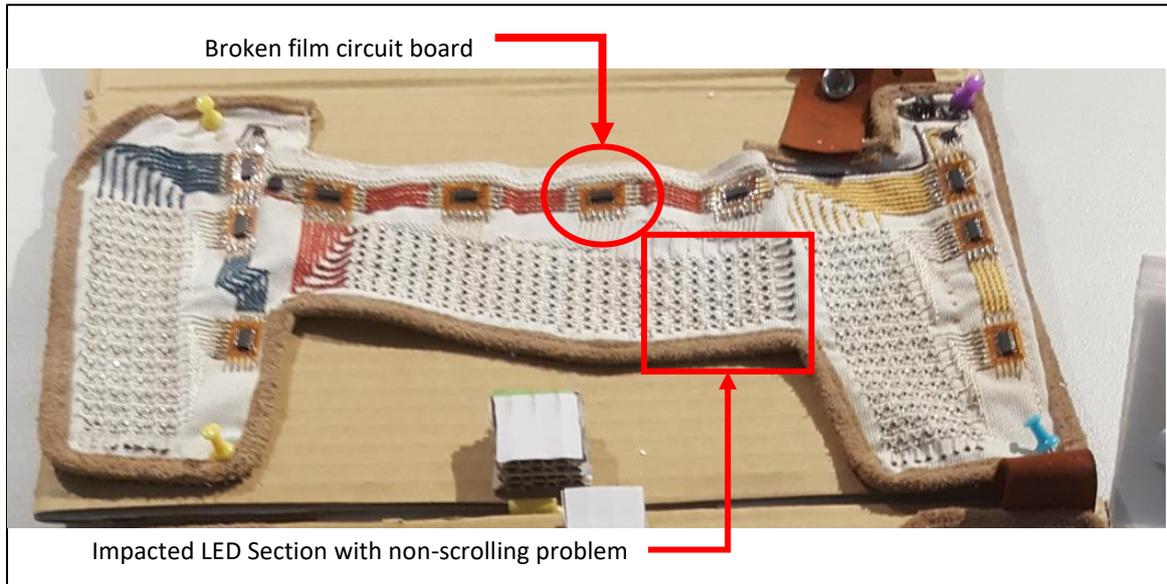
On the same artefact in Section 4.4, an electrical discontinuity was identified on one of the film circuit boards. This film circuit board (highlighted in Figure 13) has discontinuity between the mounted SN74HC595 Shift Register IC pin and film circuit board pad (highlighted in Figure 14). This particular pad is required for passing communications to the next SN74HC595 Shift Register IC in the chain, and affects the LED cluster (highlighted in Figure 13) by preventing text scrolling in the LED cluster (because no new communication can be sent to the SN74HC595 Shift Register IC controlling the LED cluster).

Figure 13 - Location and affected LED section from broken film circuit board.

In order to restore scrolling text in the LED section highlighted in Section 0, the film circuit board for the particular IC needs to be replaced.

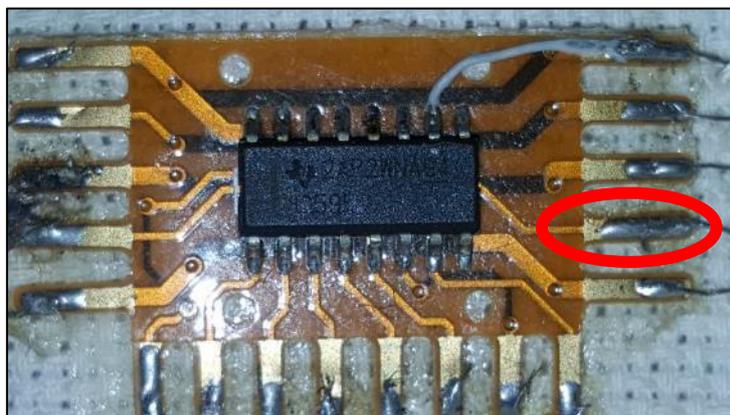
Figure 14 - pin affected by broken film circuit board, caused by either a broken IC pad, trace, or board via.
