ENGINEERING REPAIR REPORT

SHIH WEI-CHIEH – “I AM VERY HAPPY I HOPE YOU ARE TOO”
HEADDRESS ARTEFACTS

PREPARED BY ALBERT ONG

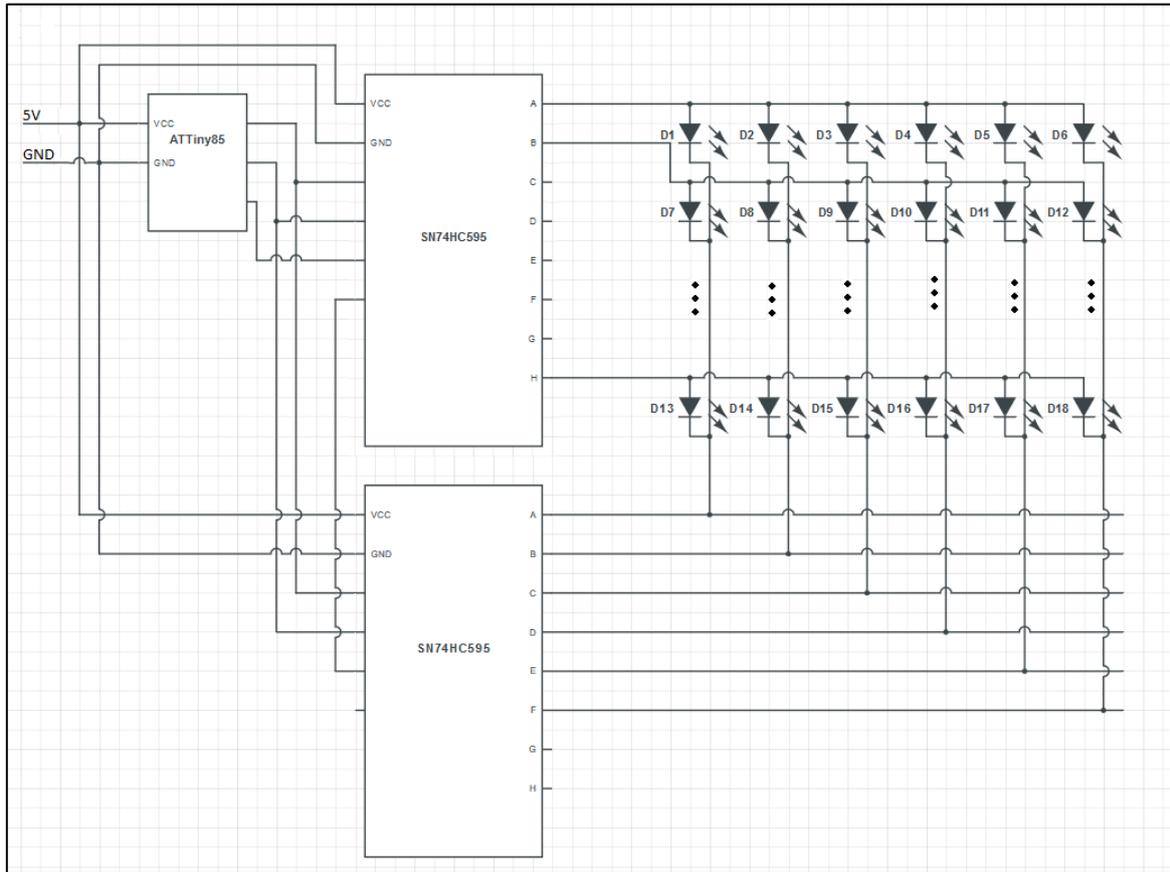
Figure 1 - High level schematic demonstrating bus lines and general LED Matrix Circuit.

Initial inspection of the circuit identified that typical digital circuit protection measures were not present on either artefact, namely **decoupling capacitors** and **current limiting resistors** as described in Section 3.2.1.. The absence of circuit protection measures risks damage to circuit components.

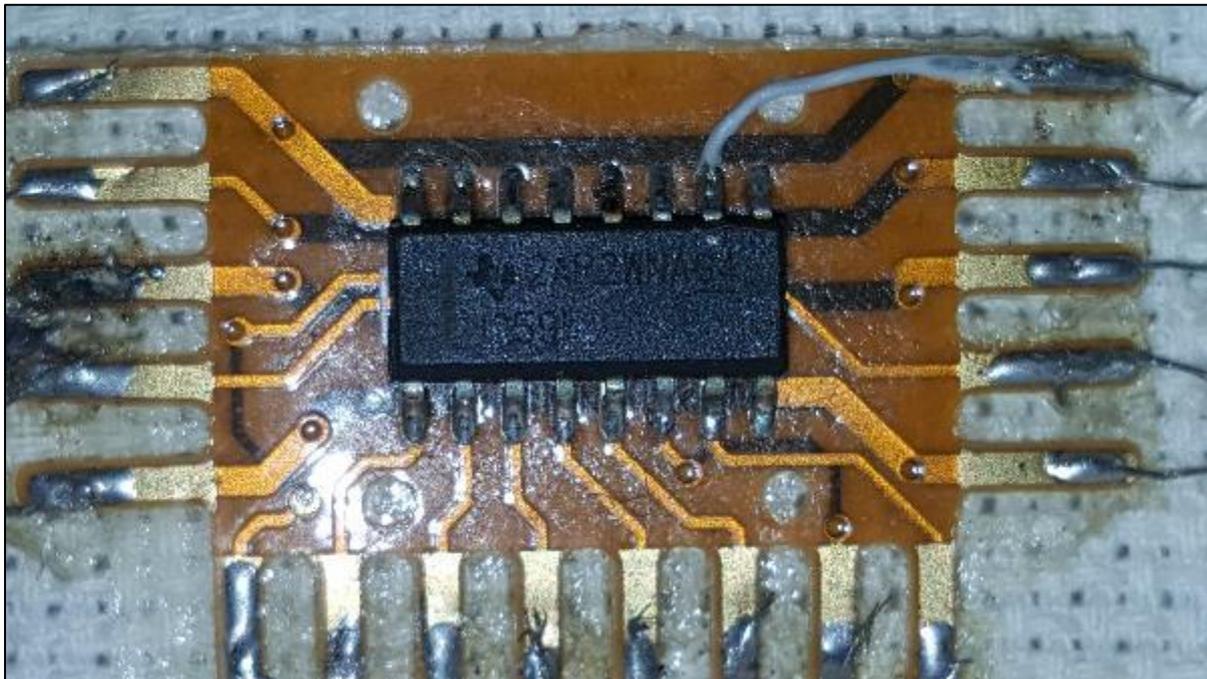
Regarding ICs installation methods used, SN74HC595 Shift Register ICs were surface mount soldered to film circuit boards. These were then subsequently glued to the fabric (see Figure 4).

Figure 4 - SN74HC595 Shift Register IC mounted to film circuit board, which is glued to fabric.

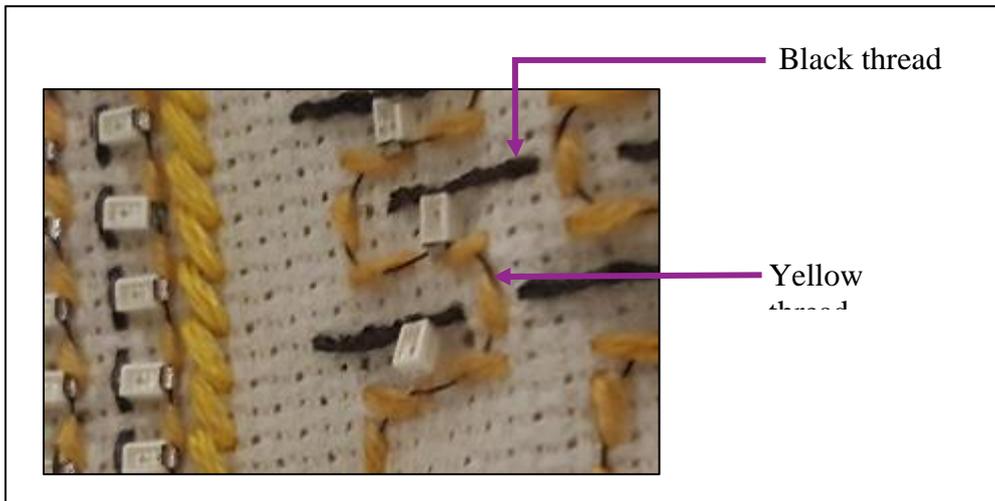
Resistance of both yellow/purple thread and black thread was also measured – testing across a length of thread length of approximately 200mm yielded a resistance of approximately:

- **Yellow/purple thread:** 15Ω / ~200mm, and
- **Black thread:** 100Ω/ ~200mm.

Figure 6 – Types of thread used to connect circuit boards and LEDs. Note the metal thread passing through the yellow thread, but not through the black thread.

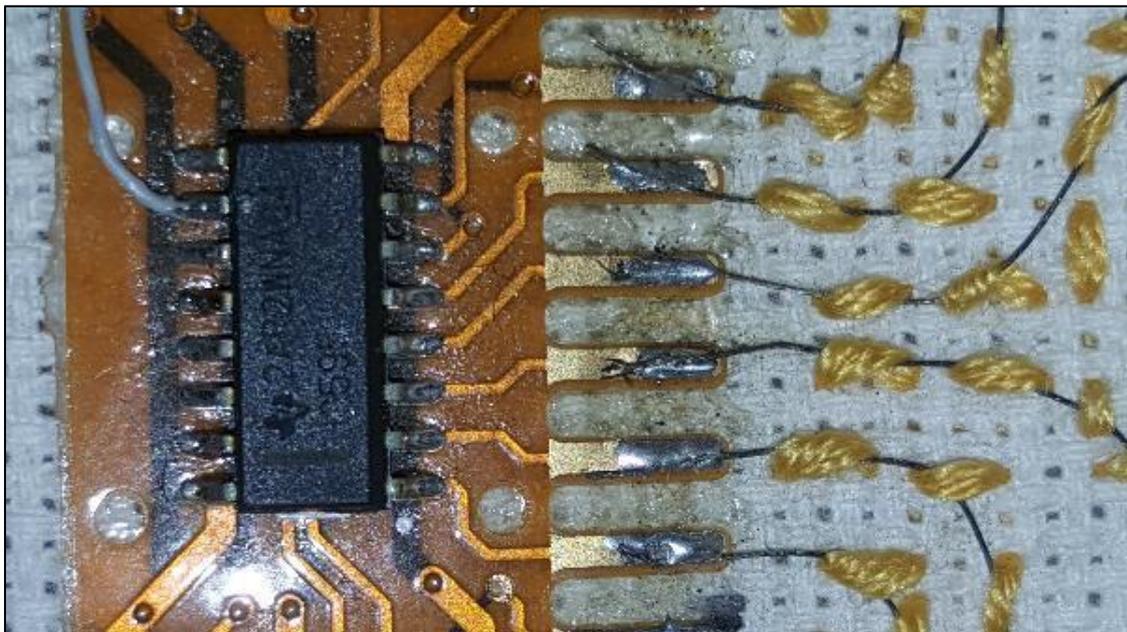
Figure 7 - Connection of thread to film circuit board

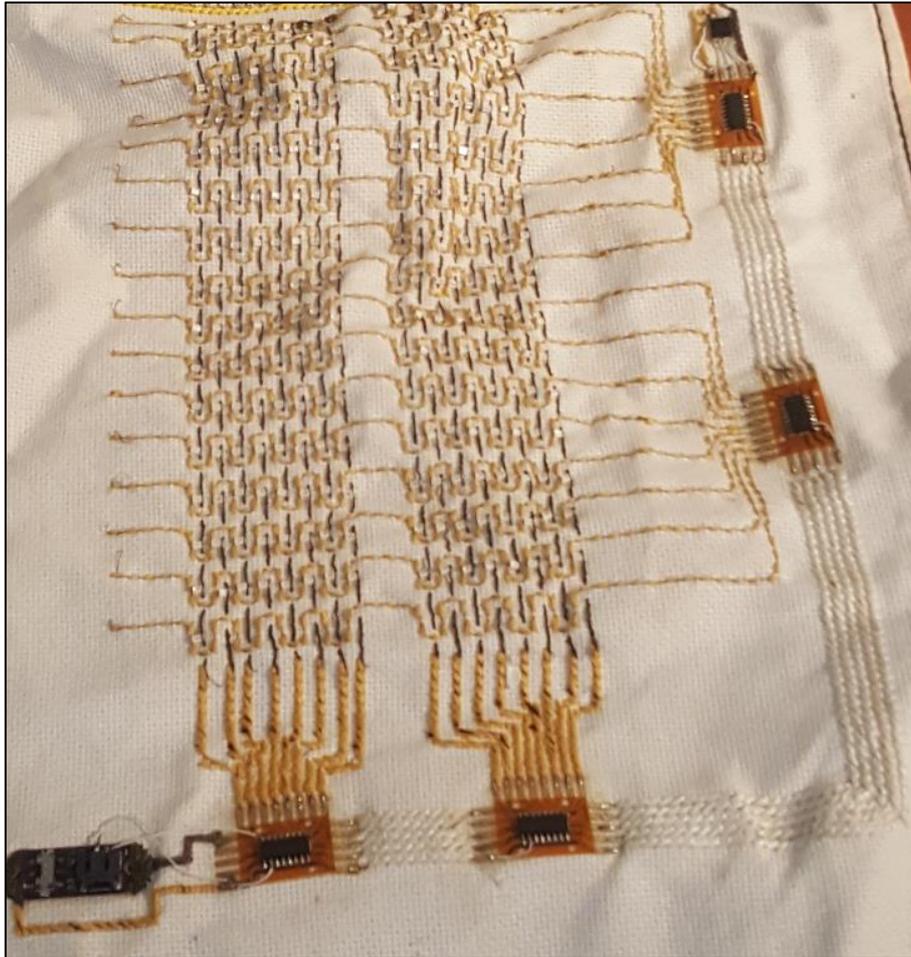
Figure 8 - Thread connections between film circuit boards, rigid circuit board (power supply connector), and LEDs
